Aqueduct Bridge (Grade II Listed)

PROJECT NUMBER: 473946

Introduction

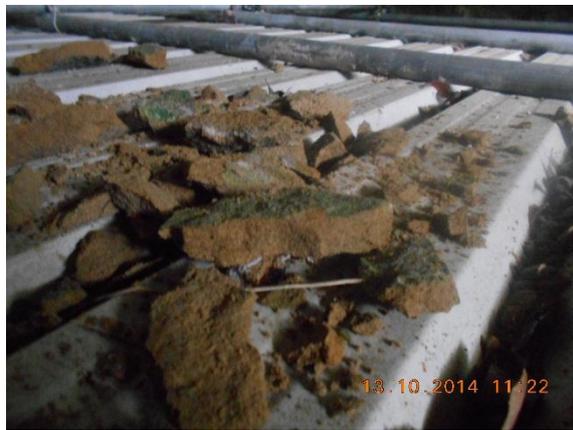
The stonework to the arch barrel is in poor condition with extensive areas of spalled and saturated masonry to the south side. During the hammer survey numerous random areas of spalled stone up to 20mm thick dislodged which highlights the ongoing deterioration of the arch barrel. No significant cracking or movement to the foundations was noted and the shape of the arch barrel appeared to be good however several viewpoints were partially blocked by the scaffolding.

Photo 1 – Removed spalled stonework

1. Carry out an intrusive trial hole investigation to determine the arch parameters.
2. Carry out an assessment of the structure to determine the theoretical minimum arch barrel thickness that can be tolerated.
3. Following the above activities review the existing monitoring regime and provide a detailed and auditable report outlining inspection frequency, action triggers and mitigation measures in accordance with BD 79/13 – The Management of Sub Standard Highway Structures.

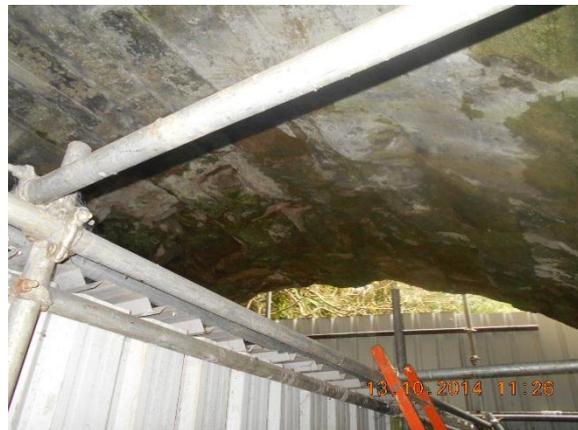
Photo 2 – Typical view of south side of barrel

This ongoing moisture saturation and freeze thaw cycles will continue to deteriorate the stonework and reduce the overall thickness of the arch barrel. This deterioration will lessen the structures load carrying capacity and eventually lead to isolated areas of failure (collapse). At this stage there is a low likelihood and no indications that the structure will fail catastrophically as no hinge points or movement to the foundations appear to have formed. However it is necessary to assess any risk and determine when the structure will become a danger to the public. A detailed assessment of the structure could be carried out to determine the theoretical minimum arch barrel thickness. As the structure is subjected to limited live loading (pedestrian only) and the bridges own dead weight has a
